Erosion-related Considerations

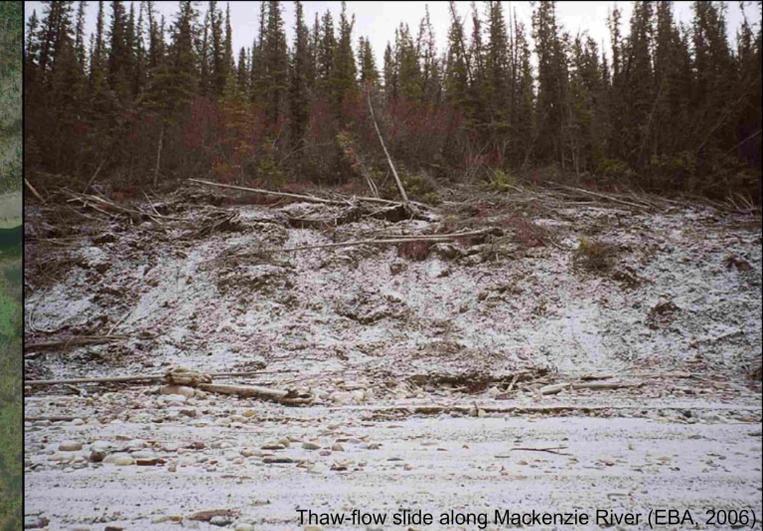
Thaw-flow slide along Mackenzie River (EBA, 2006)
