Erosion-related Considerations

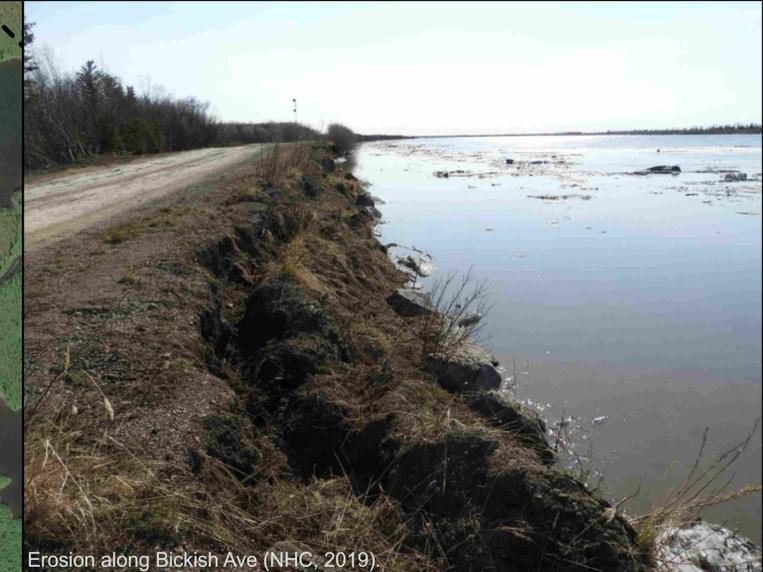
Erosion along Bickish Ave (NHC, 2019).

- Community sits on soft, easily eroded sediments
- Nearby ponds are becoming more connected to the river as the permafrost surrounding them thaws
- Ongoing erosion along Bickish Avenue, with some attempts at protecting the toe of the slope
- Outer bank of sharp bend of Peel Channel has migrated more than 100 m away from the community over the last 50 years
- Recent flooding in community contributes to bank erosion
