### Erosion-related Considerations

**FORT SMITH MÉTIS COUNCIL  
(THEBACHA RECREATION AREA)**

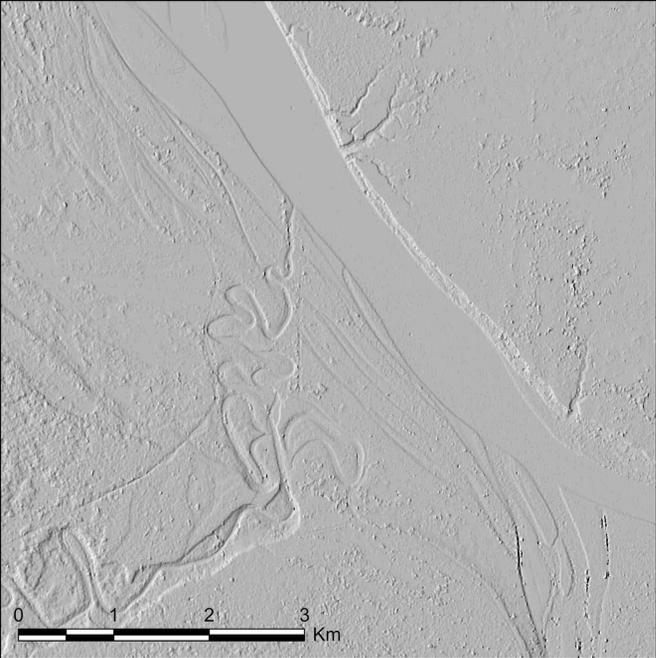
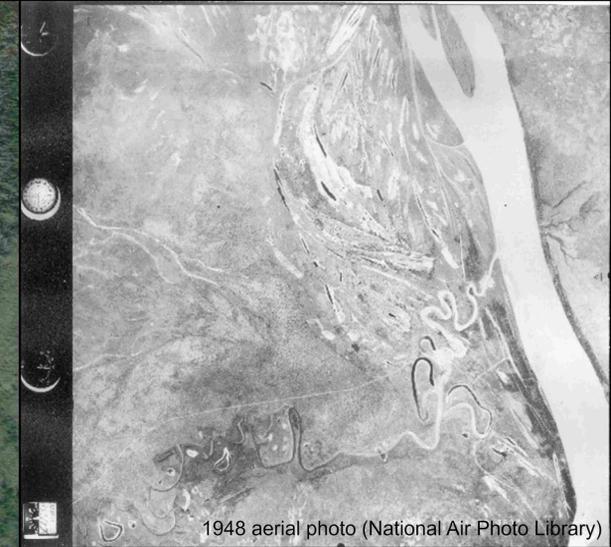
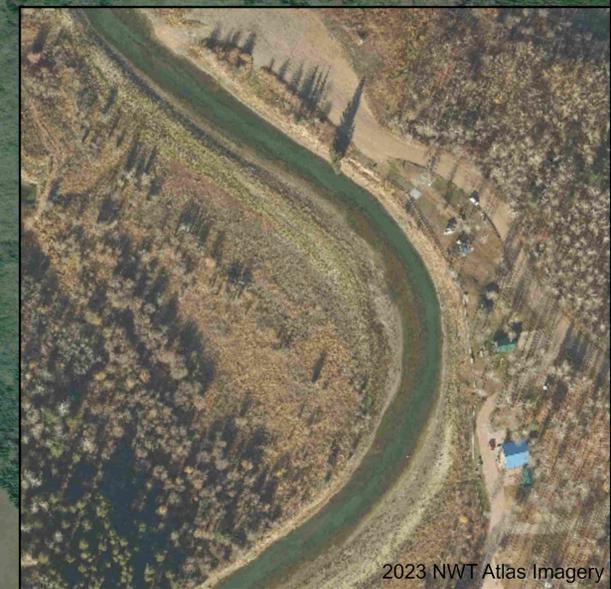
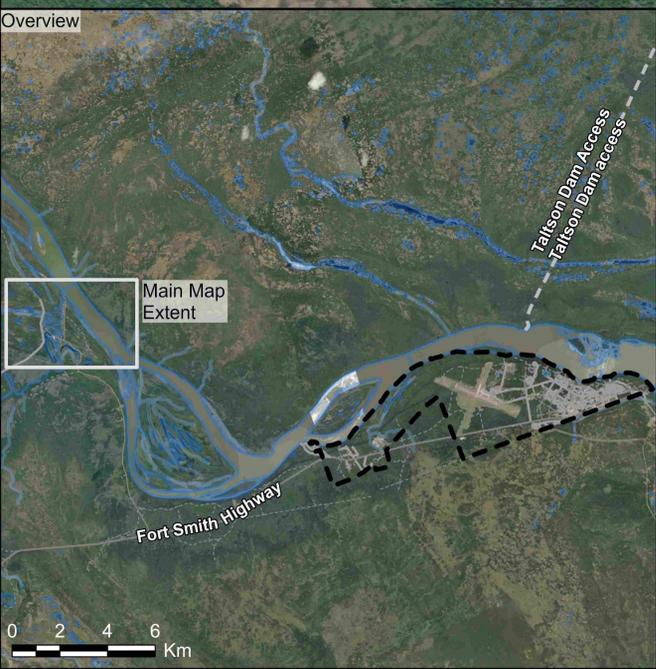
- Salt Creek and Slave River has not changed much since 1948
- Erosion potential along outer banks of sharp channel bends
- Natural 'cut-off' of sharp bend of Salt Creek, upstream of the campground, slightly steepened the channel and may accelerate downstream bank erosion
- Permafrost not known to be a key contributor to riverbank instability
