Erosion-related Considerations

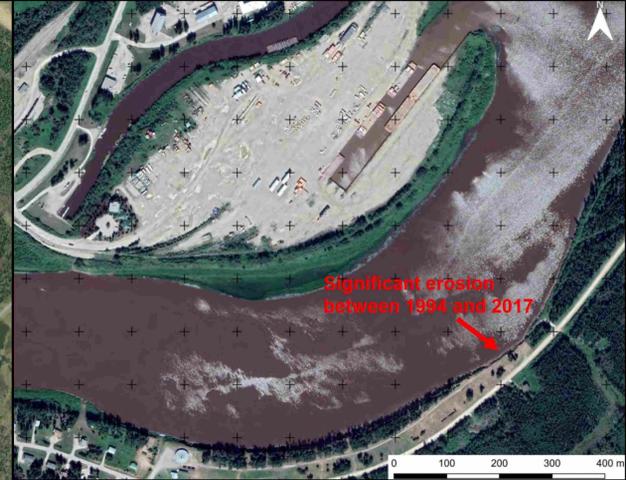
- Kátł'odeeche located alongside meanders of the Hay River delta
- Notable erosion along eastern bank across the river from Terminal C
- Berming and blockage of side channels at Terminal C has likely sent some erosive energy toward reserve lands along the opposite side of the river
- Permafrost not known to be a key contributor to riverbank instability

Location of notable bank erosion (Baird, 2019)
