- ### Erosion-related Considerations
- Community is near where South Nahanni River and Liard River meet
  - Islands of South Nahanni River have changed slightly in size and shape in recent decades
  - Bedrock 'spur' upstream of community deflects erosive flows toward the community
  - South bank of river within the community has eroded about 1 metre every year, on average, over past 25 years (Trek Geotechnical, 2025)
  - Recent assessment recommended installation of riprap along eroding bank (Trek Geotechnical, 2025)
  - Permafrost not known to be a key contributor to riverbank instability

## NAHANNI BUTTE

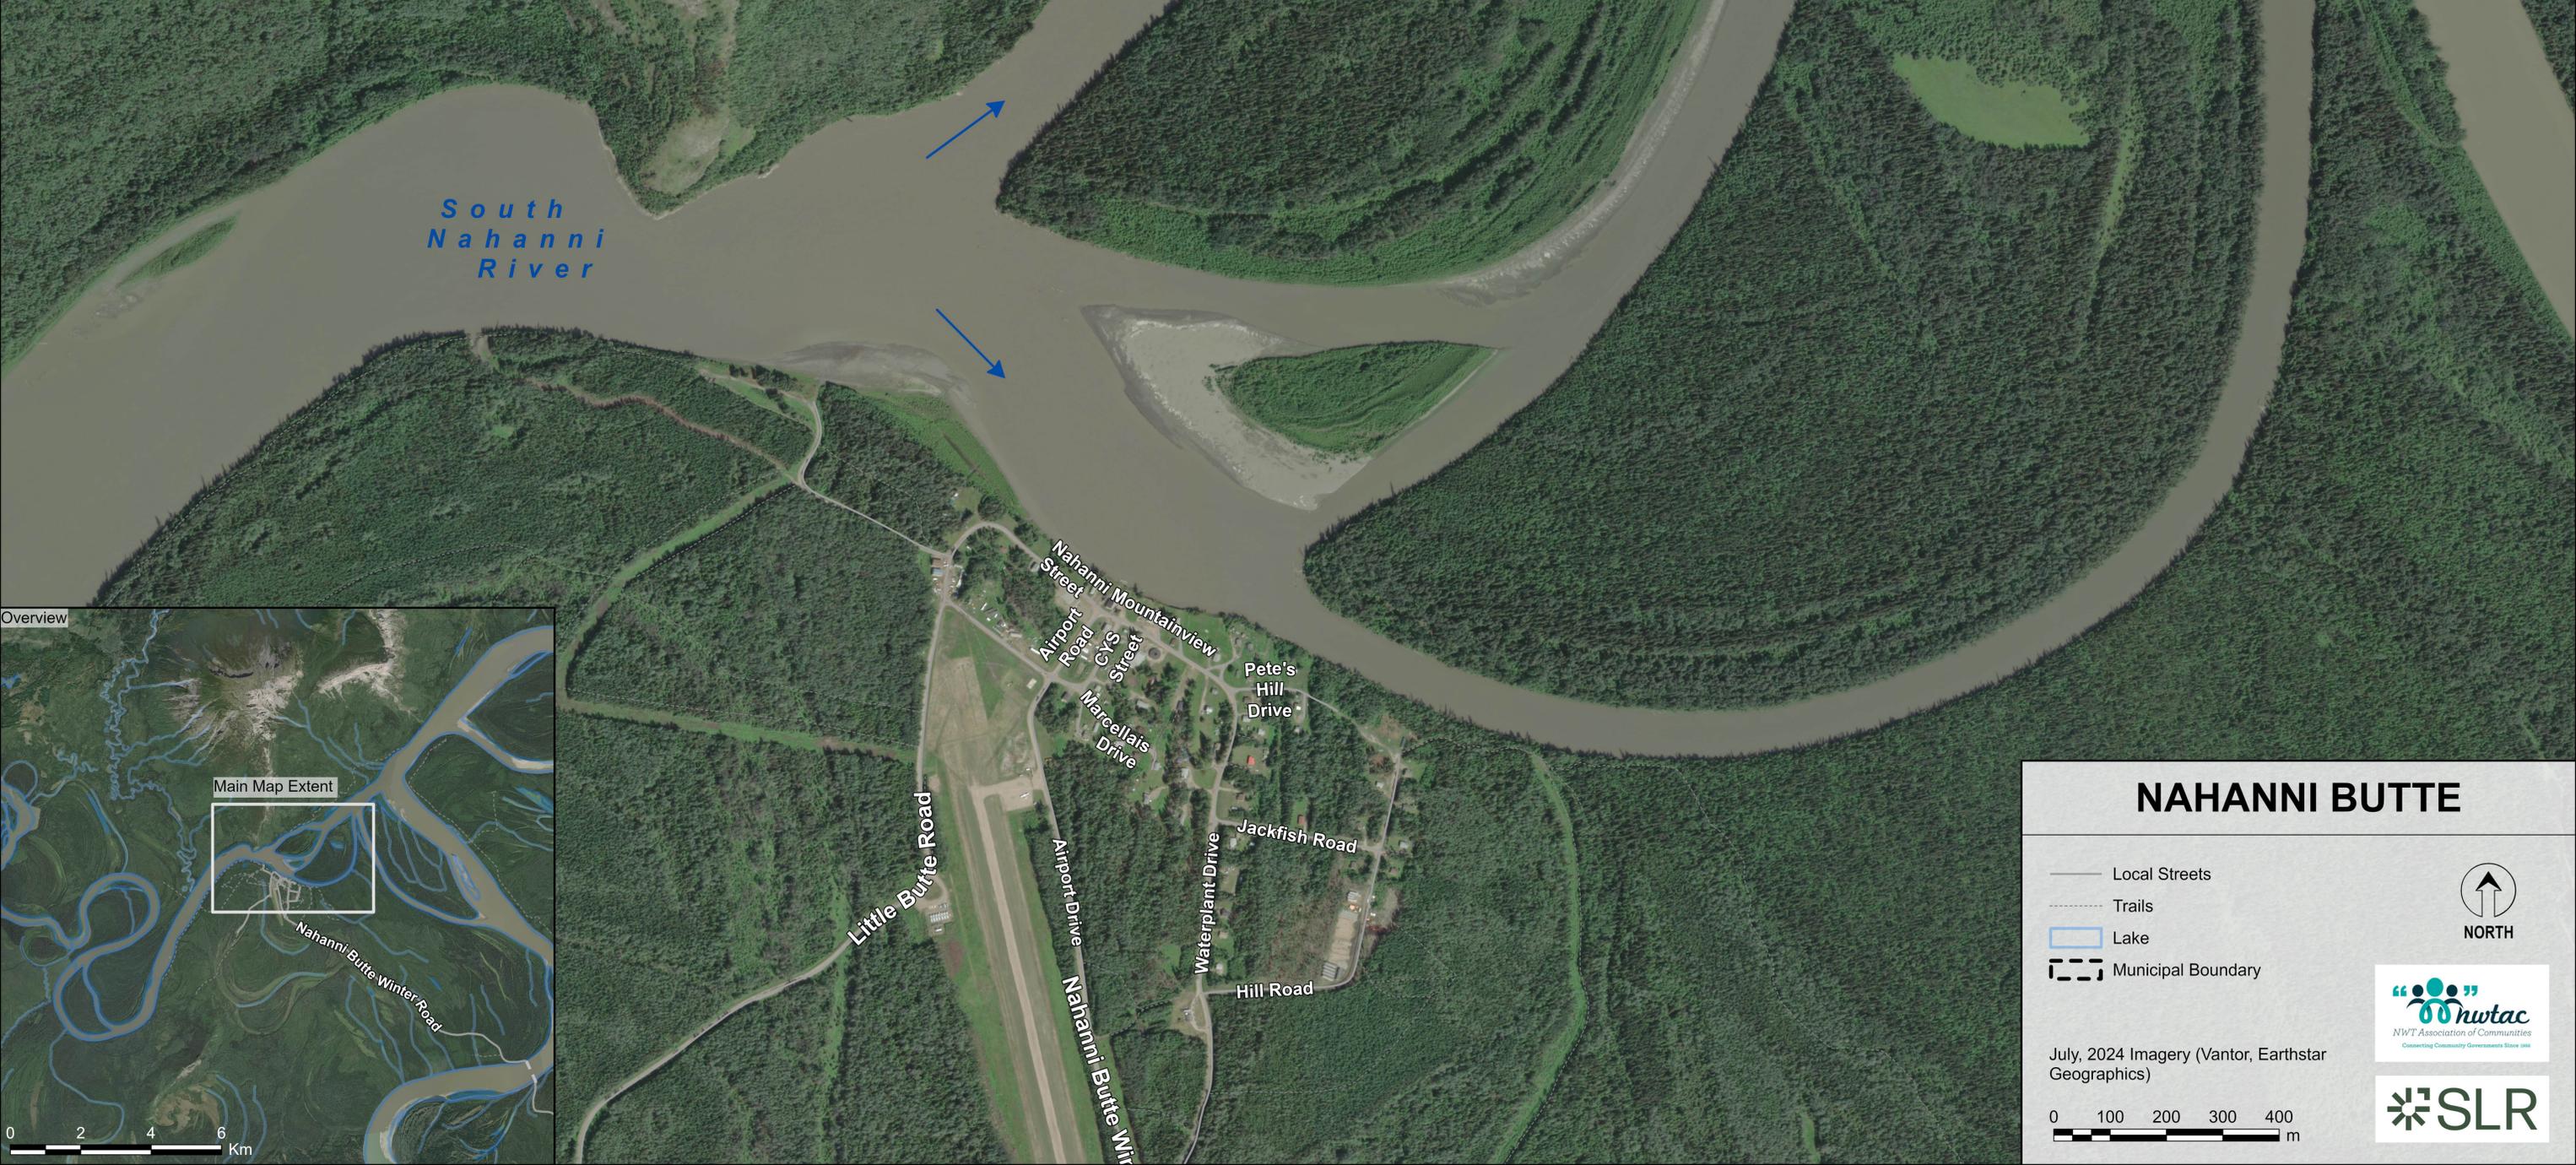
July, 2024 Imagery (Vantor, Earthstar Geographics)
