Erosion-related Considerations

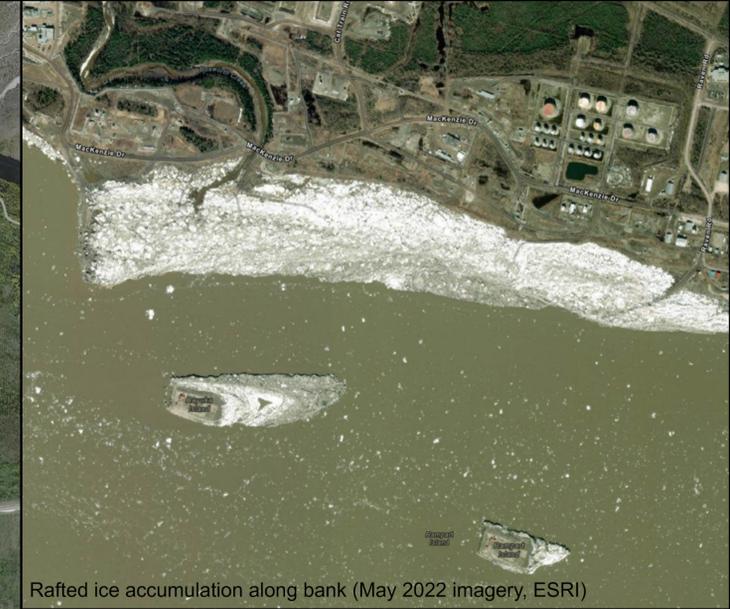
Rafted ice accumulation along bank (May 2022 imagery, ESRI)

- Community located across from large, vegetated islands and drilling and oil production platforms within Mackenzie River
- Berms and groynes constructed along the bank to help control sediment movement
- Uncontrolled surface runoff has led to gullying and erosion
- Water, ice scour and permafrost thaw also contribute to erosion
- Bosworth Creek also has a history of eroding its banks and placing nearby roads at risk
