Erosion-related Considerations

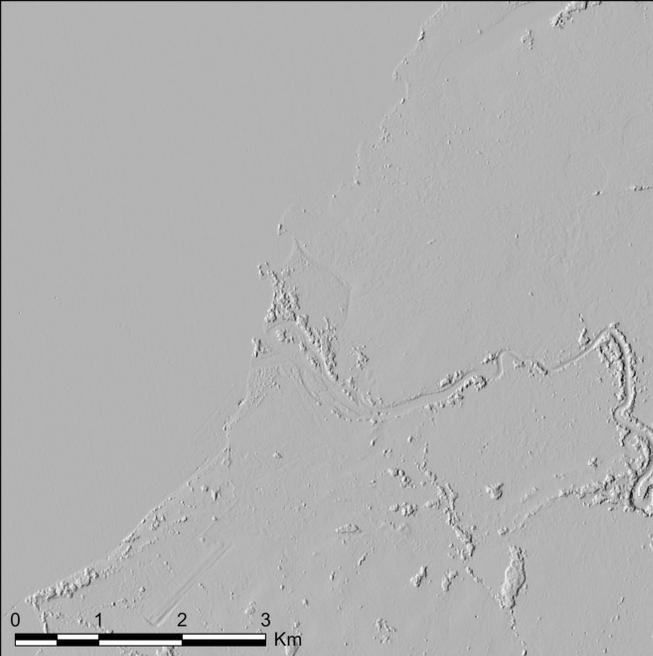
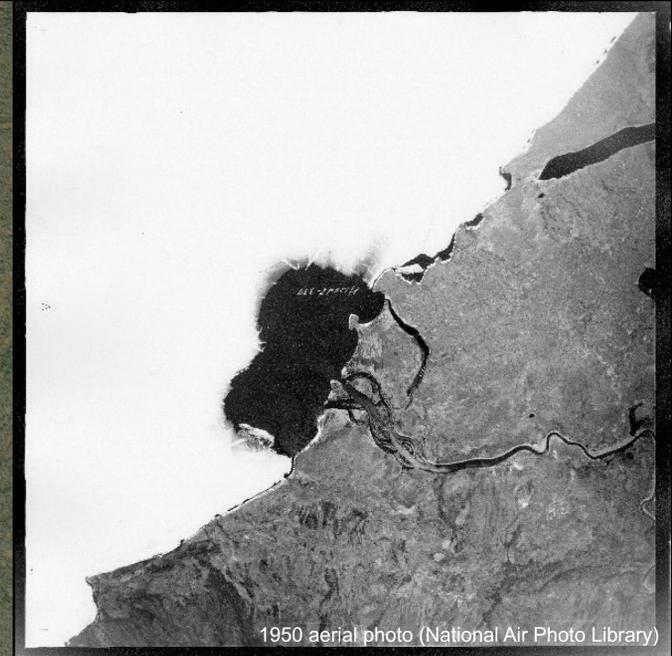
1950 aerial photo (National Air Photo Library)

- Located on a delta of Ndu Tah Deh (Island River) along the southern shore Trout Lake
- Channels tend to change positions every so often within deltas in response to floods and build-up of sediment
- Construction of old airstrip blocked a channel within the delta, which has changed erosion patterns
- The Trout Lake shoreline has not changed much over the past 75 years
- Permafrost not known to be a key contributor to riverbank instability
