### Erosion-related Considerations

## TSIIGEHTCHIC

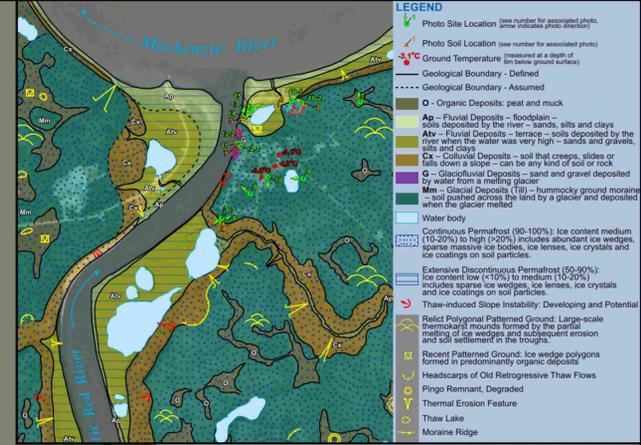
Surficial geology and permafrost mapping (EBA, 2011)

- Community is situated on the outer bend of Arctic Red River, where it meets Mackenzie River
- Growth of nearby ponds over time is a result of thawing ice-rich permafrost
- Thaw flows caused by erosion of the slope toe and thawing ice-rich permafrost are impacting the cemetery
- Some mitigation has previously been proposed but it is recognized that multiple drivers of instability must be addressed

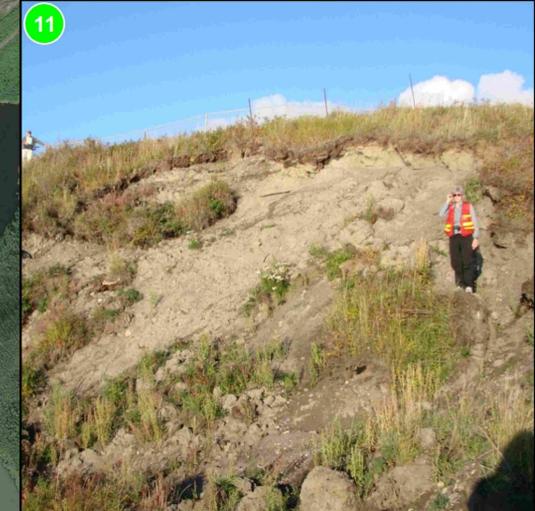
Thaw slide near cemetery (EBA, 2011)
