Erosion-related Considerations

WRIGLEY

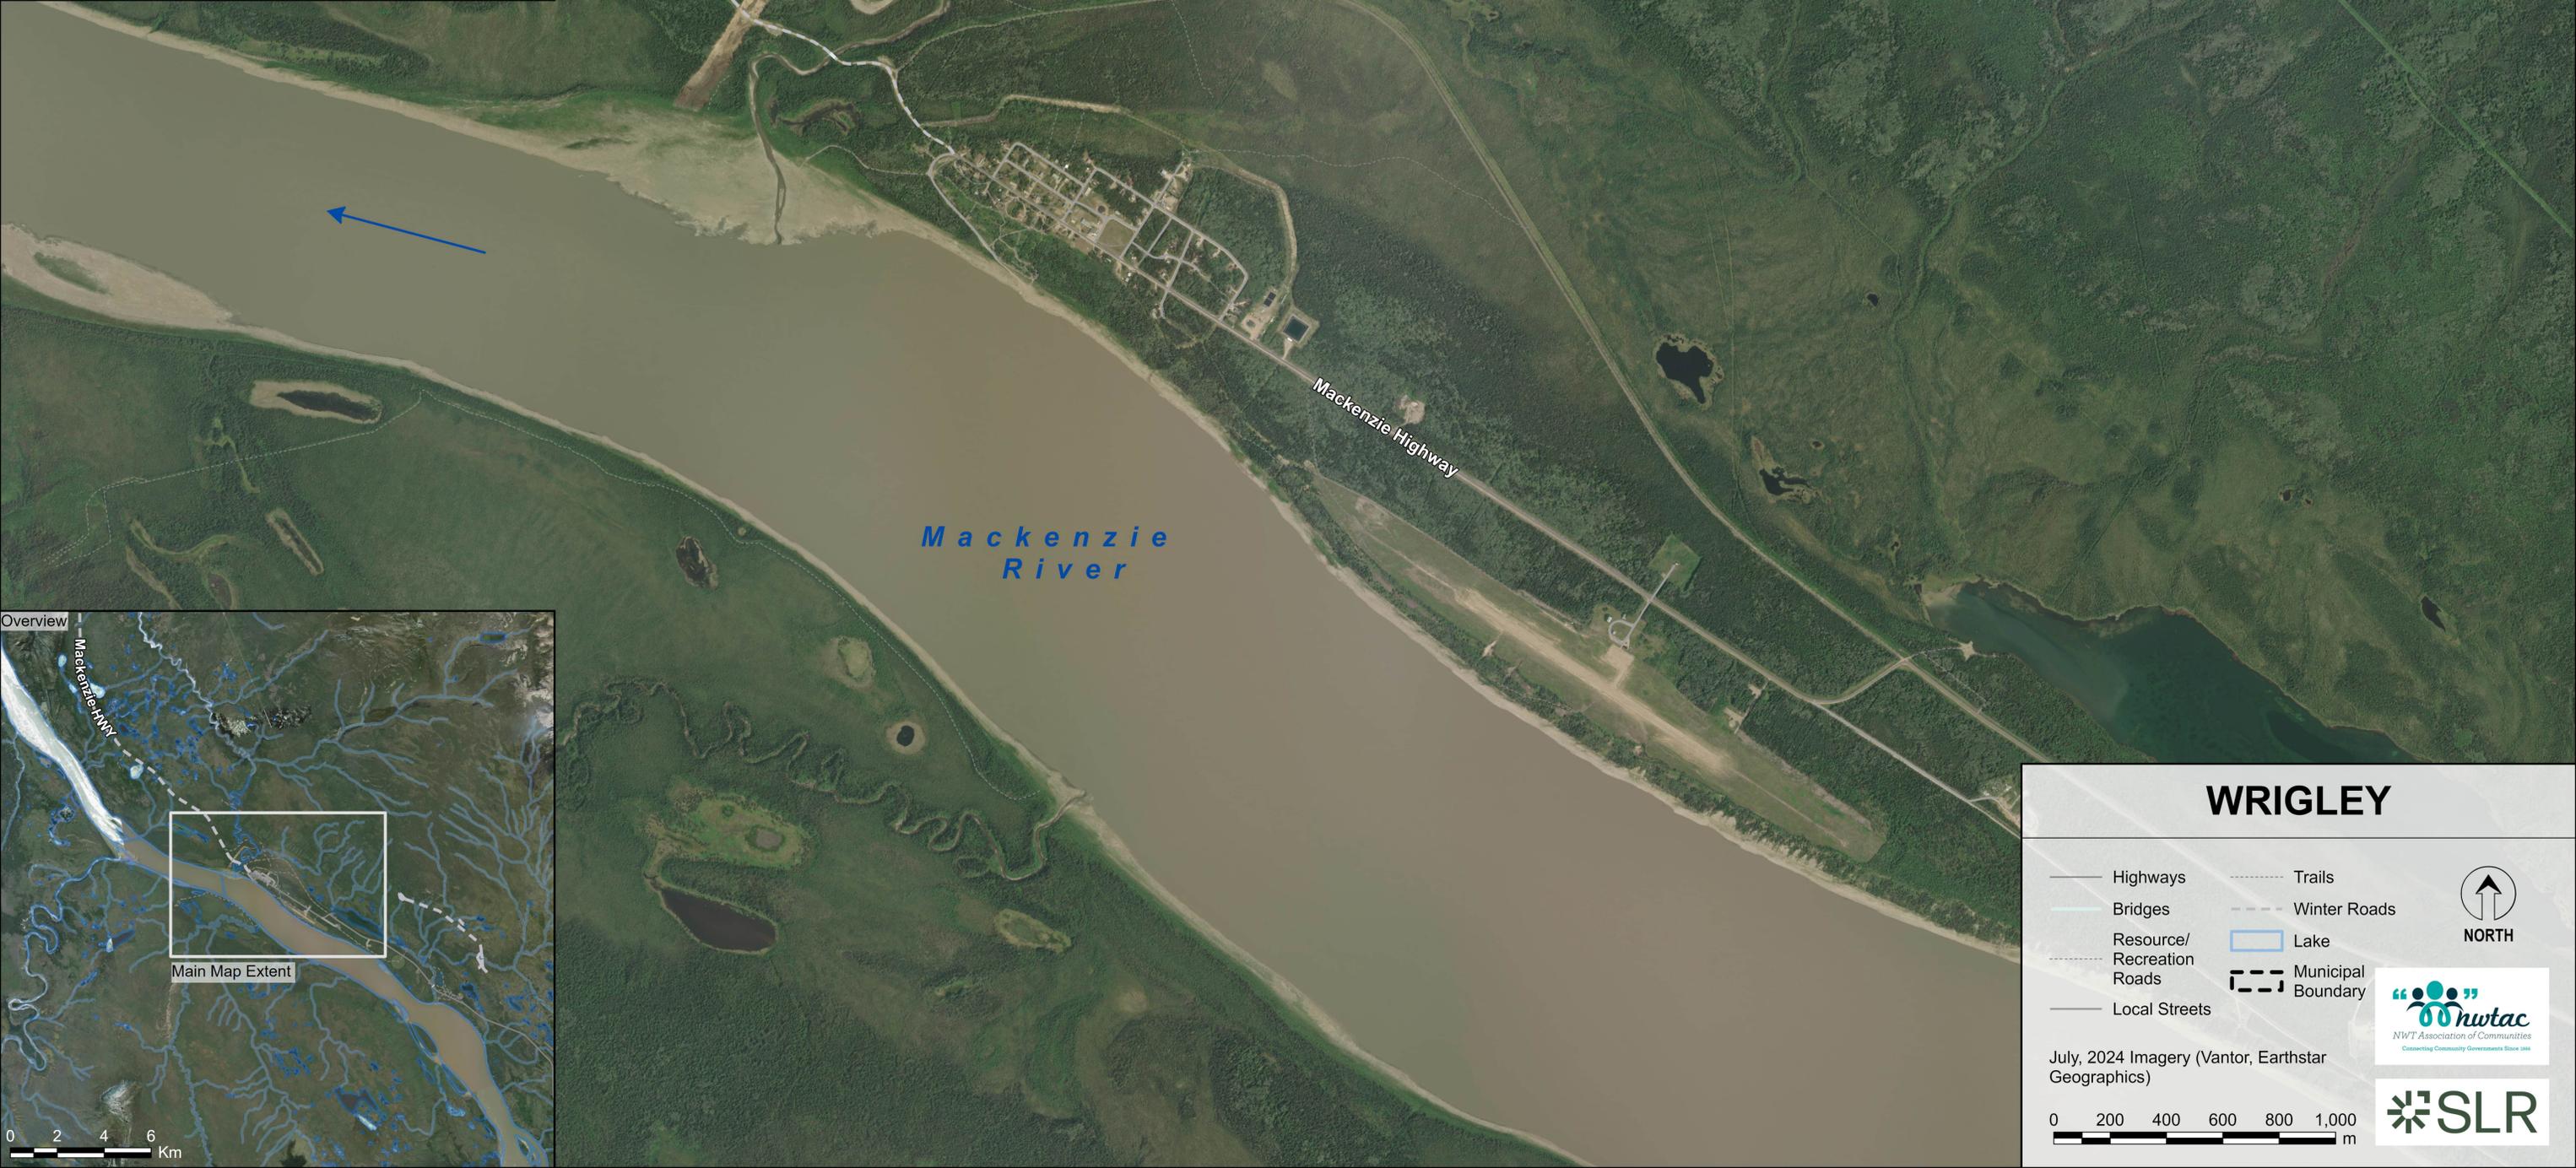
- The community sits on a high terrace – the floor of an ancient channel
- Old landslide scar on 40 m-high slope along Mackenzie River
- Uncontrolled surface drainage and erosion of the toe of slope can contribute to instabilities
- Heads of deep gullies are eroding toward airstrip
- Permafrost not known to be a key contributor to riverbank instability
