### Erosion-related Considerations

## FORT LIARD

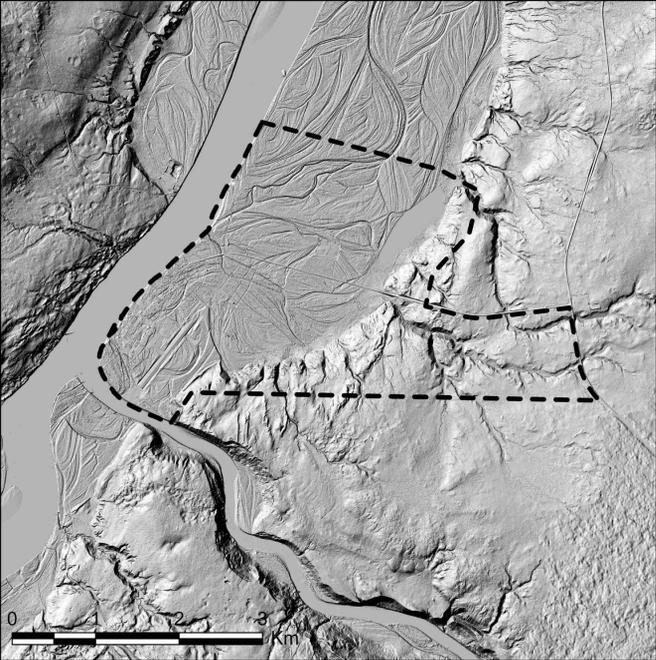
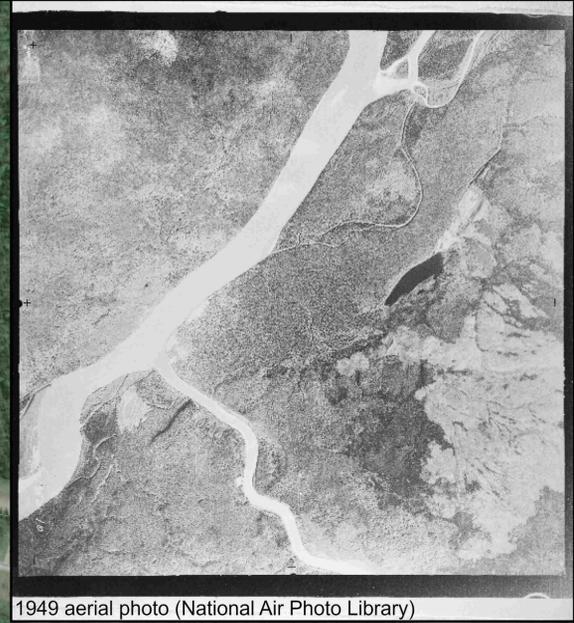
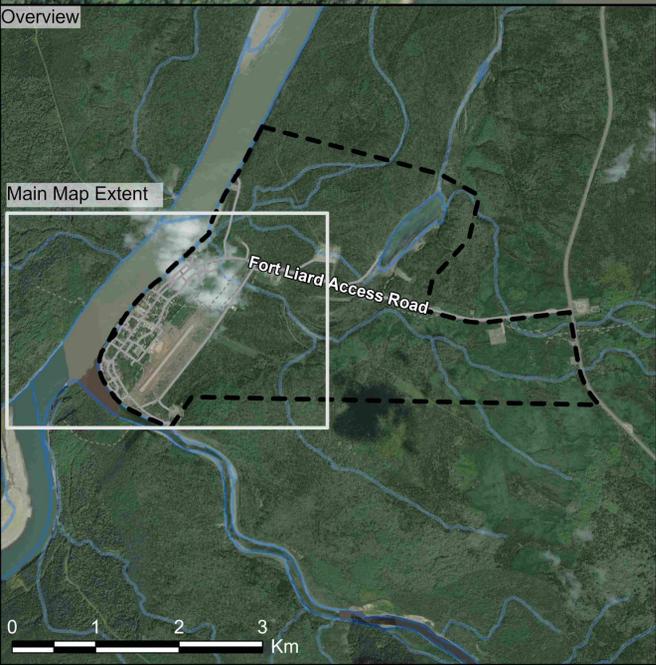
- Community is located where two rivers meet
- Petitot River may be eroding lands at west end of community
- Petitot River breaks up before Liard River and jams at the mouth
- Landslides on hillside across Liard River from community
- Permafrost not known to be a key contributor to riverbank instability
