Erosion-related Considerations

FORT MCPHERSON

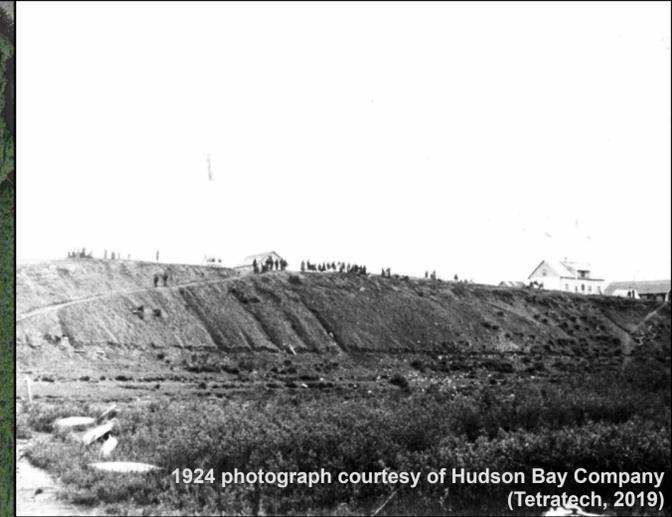
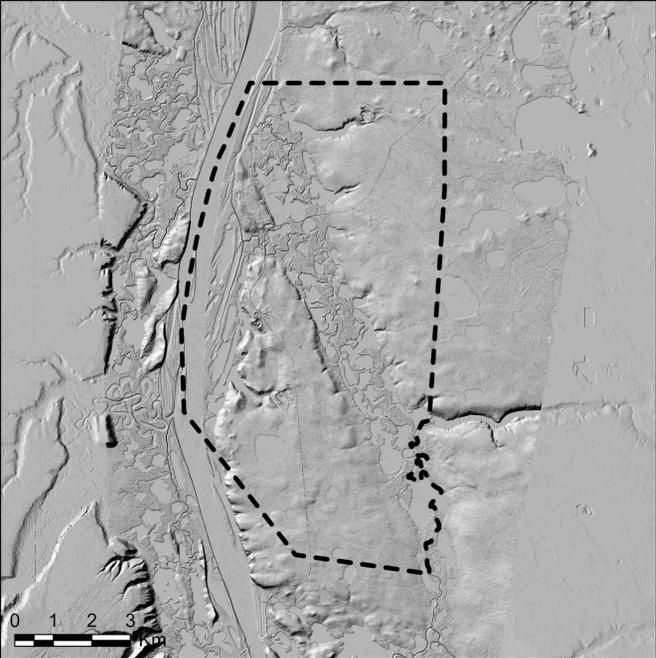
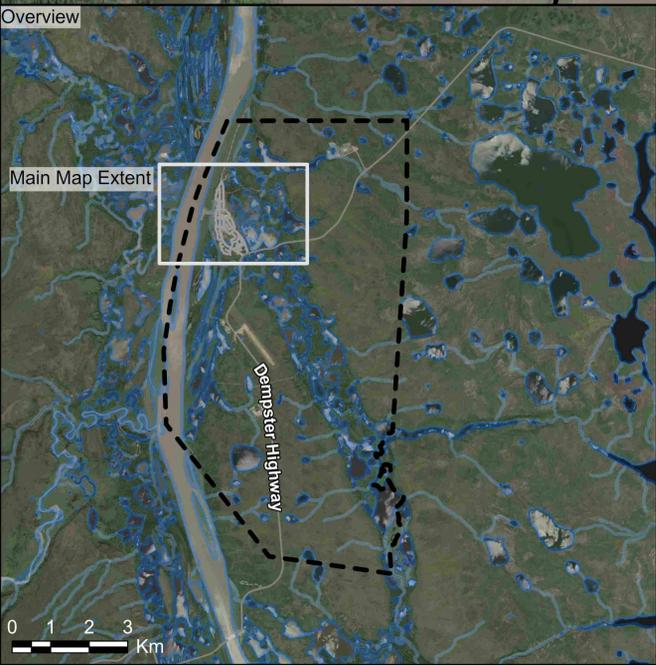
- Community located on terrace between Peel River and ancient channel
- Nearby ponds are becoming larger and connected in response to thaw of ice-rich permafrost that surrounds them
- Gullying and landslide near cemetery and church
- Flood (side) channel at the bottom of the western slope
- Thaw of permafrost underlying town likely contributing to instability
