Erosion-related Considerations

- High potential for erosion downstream of long, bedrock section of river
- 1968 large landslide
- Permafrost thaw, high groundwater table, and weak clayey layer contribute to slope instability

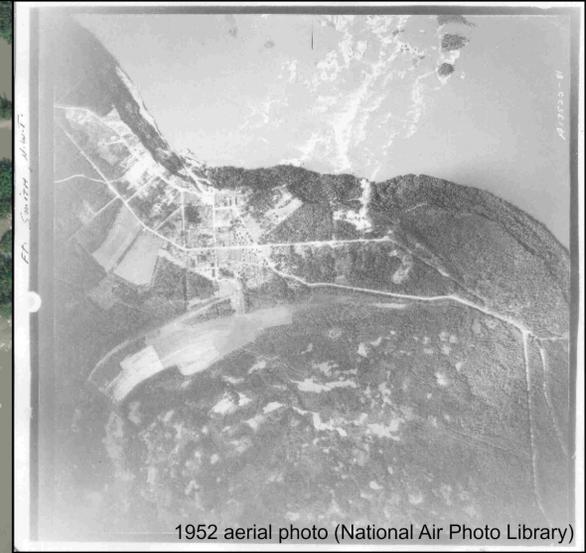
1952 aerial photo (National Air Photo Library)

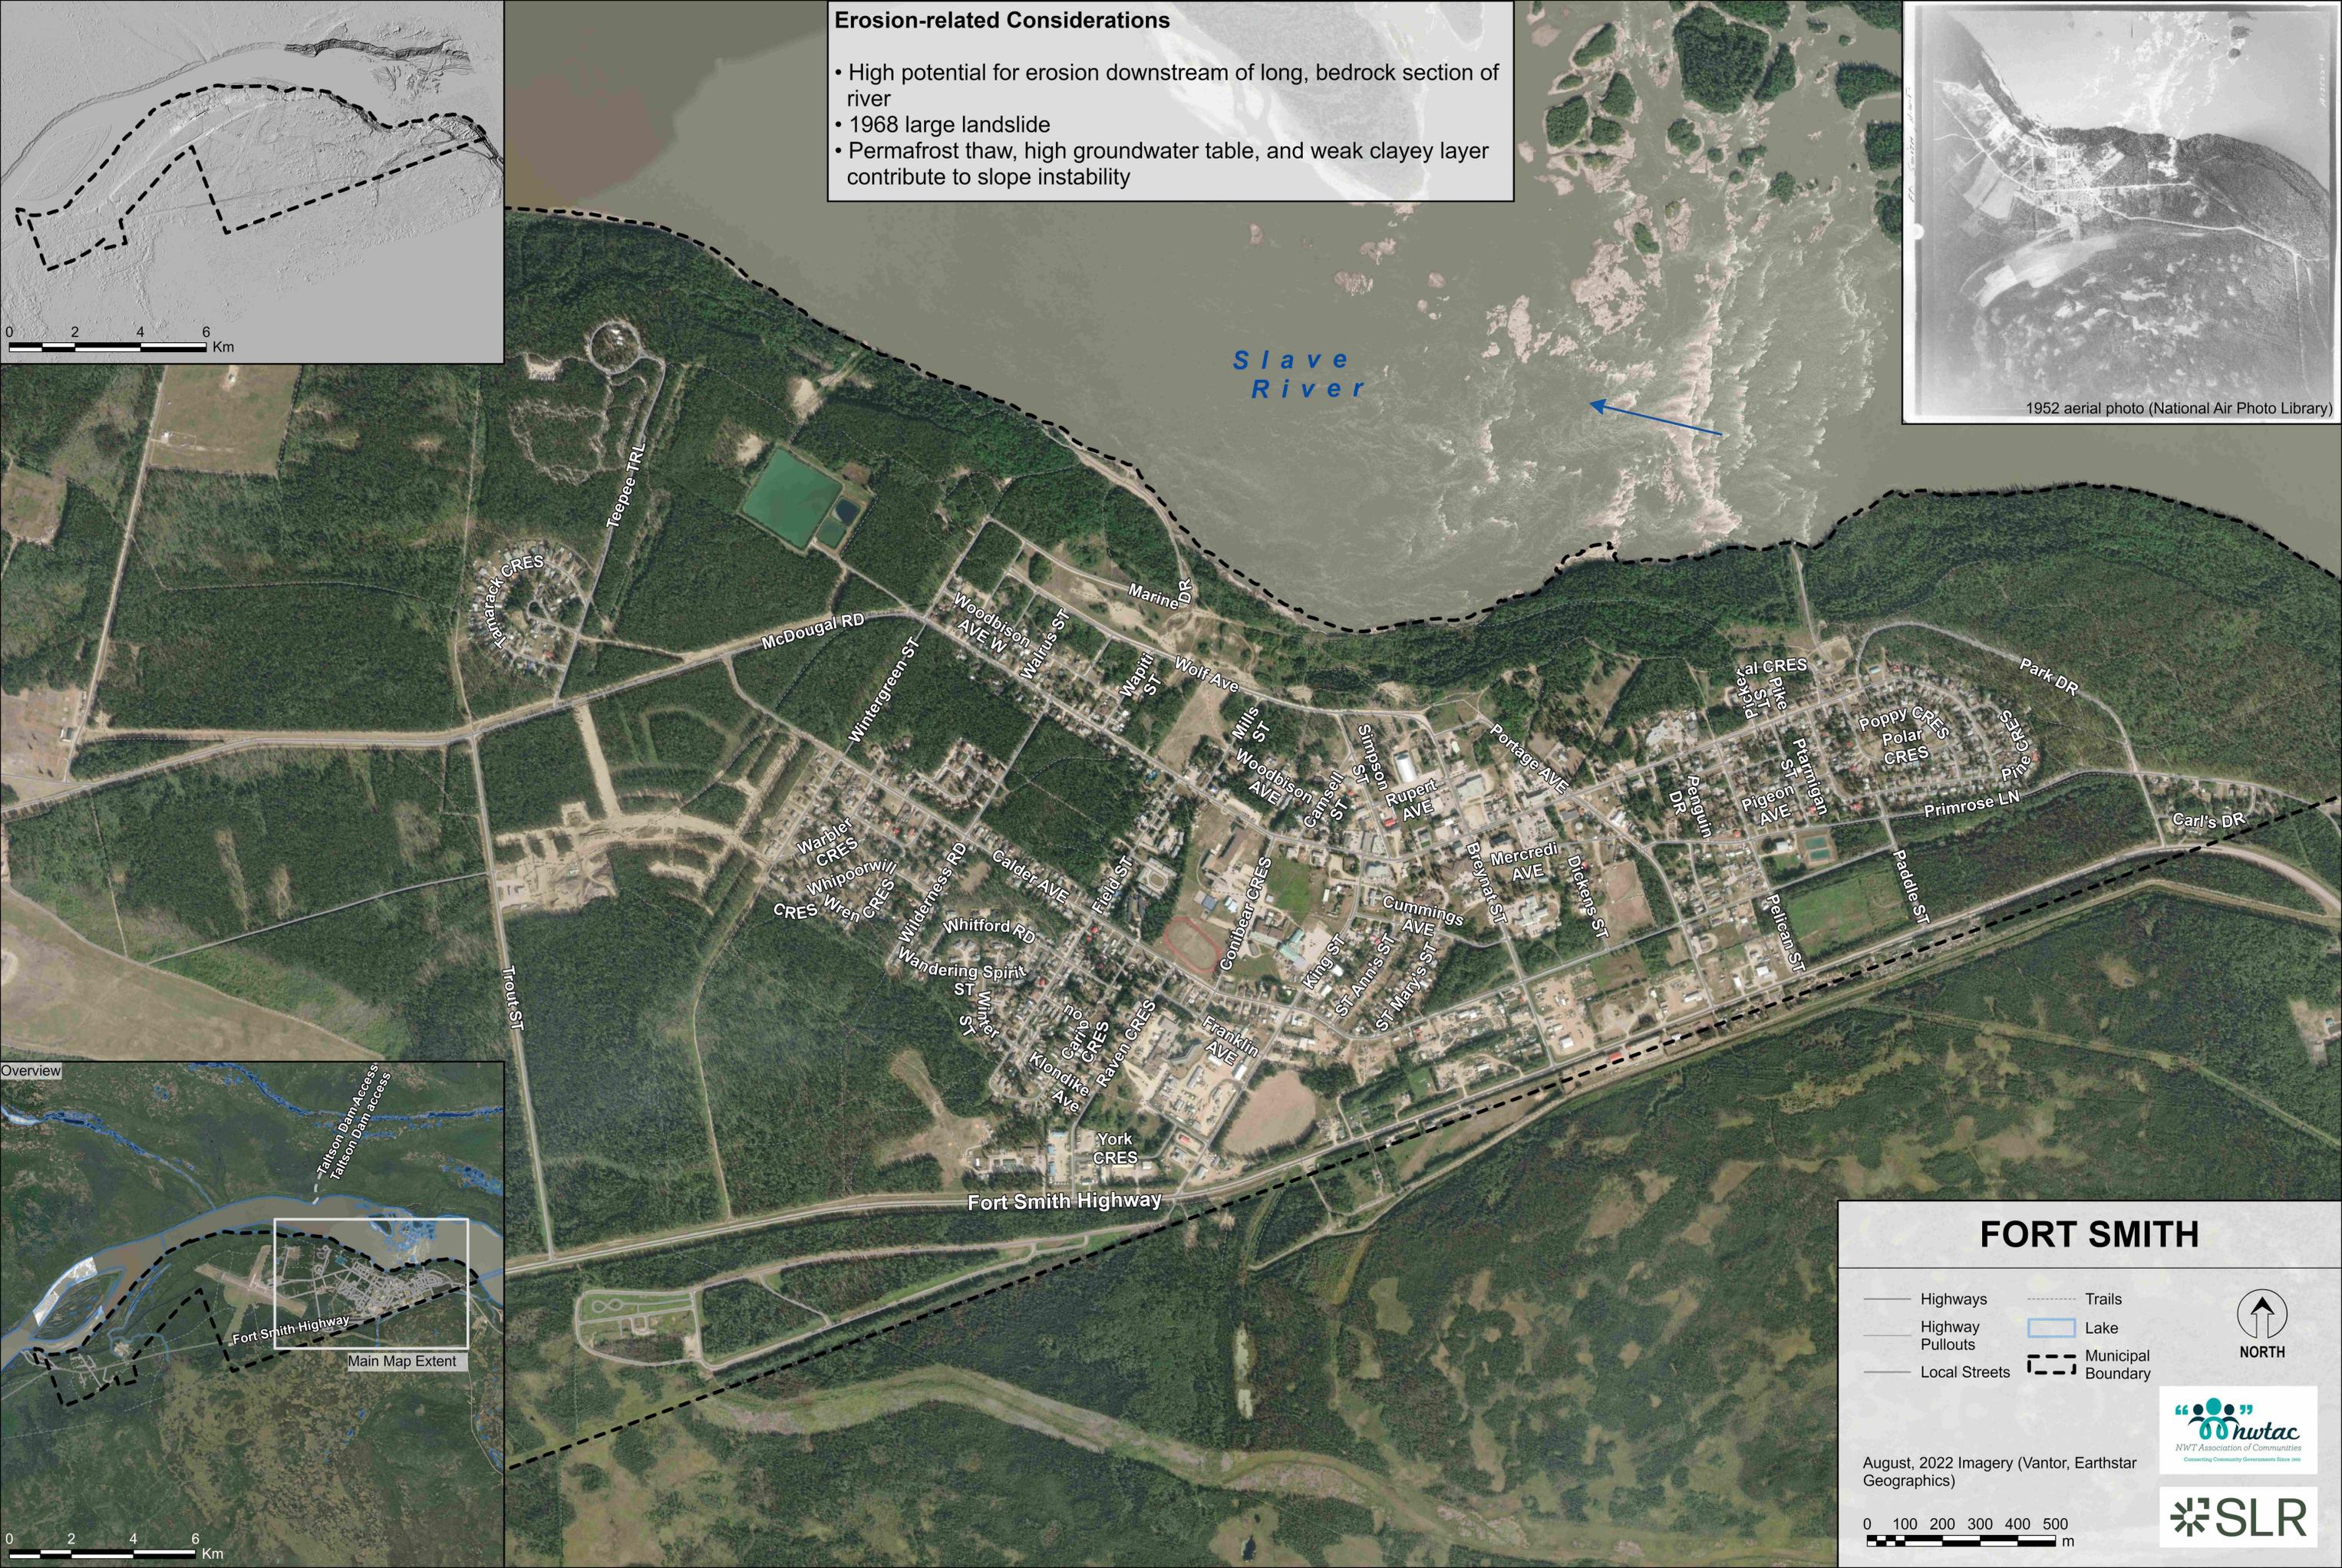
August, 2022 Imagery (Vantor, Earthstar Geographics)
