- ### Erosion-related Considerations
- Community is situated where a large river spreads across a delta
  - Urban development along both banks has altered natural flooding and erosion processes along the river and delta
  - Armouring and joining islands (Terminal C) changes flow paths on the delta
  - Shoreline of Great Slave Lake has changed in some areas over time because of river and coastal processes
  - Permafrost not known to be a key contributor to riverbank instability

## HAY RIVER

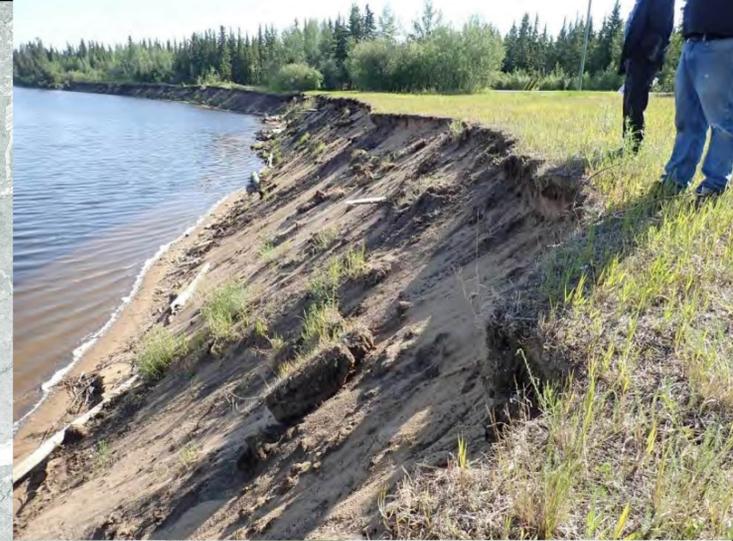
Eroding bank near Terminal C (Baird, 2019)
